Rathcoole Woodlands

Freshwater Ecology Survey

Version number 2

07/11/2024

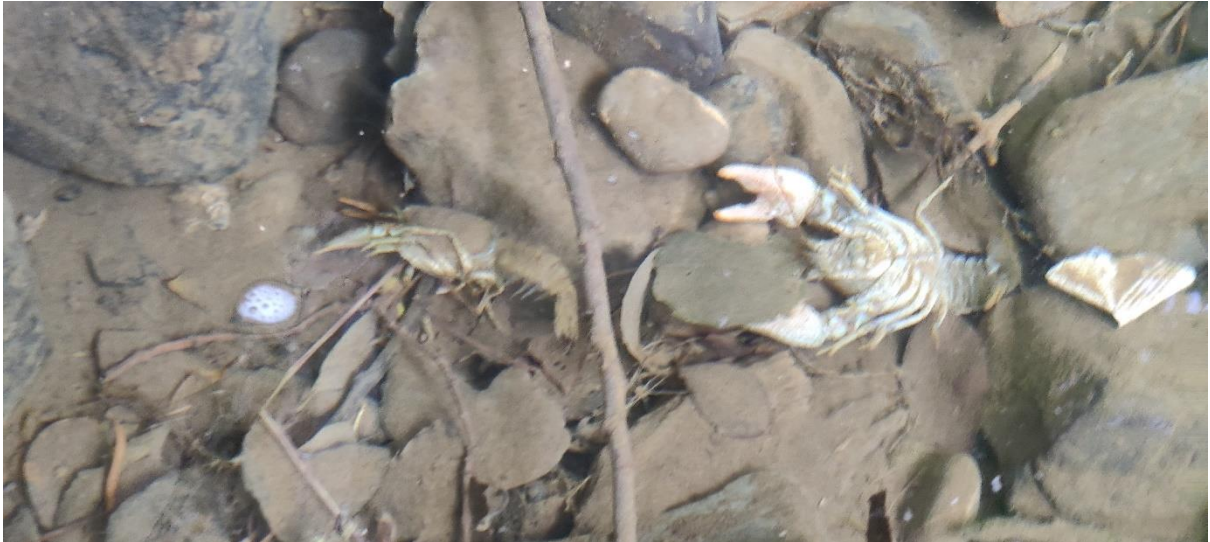
Plate 3-1: Dead white-clawed crayfish found in the Camac up and downstream of the weir following a pollution incident in August 2023. Photo credit Annie Flynn.

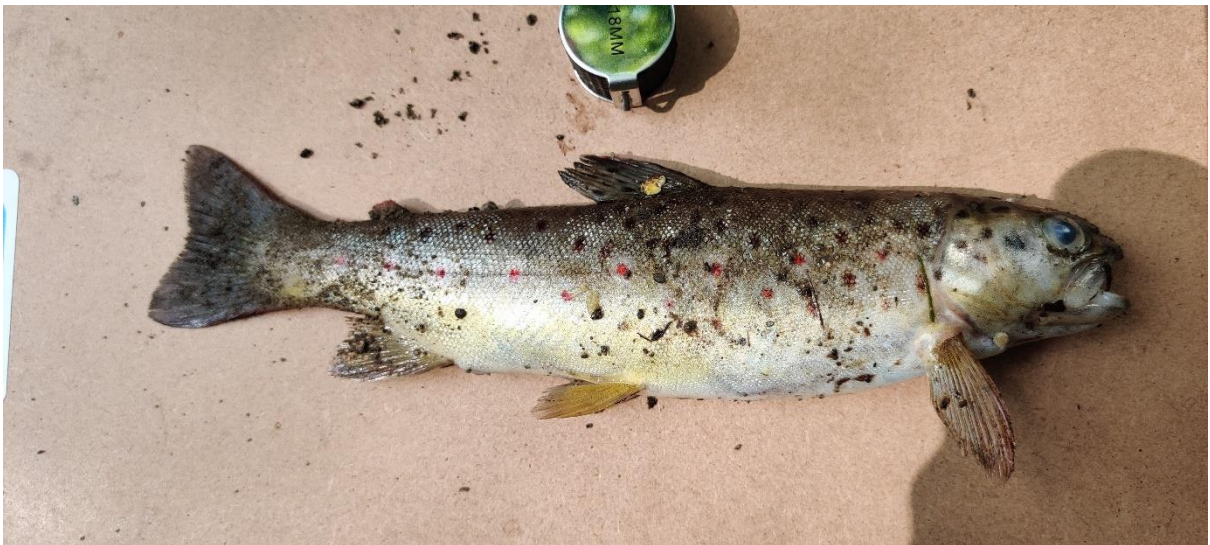
Plate 3-2: Dead brown trout found in the Camac up and downstream of the weir following a suspected incident in August 2023. Photo credit Annie Flynn.

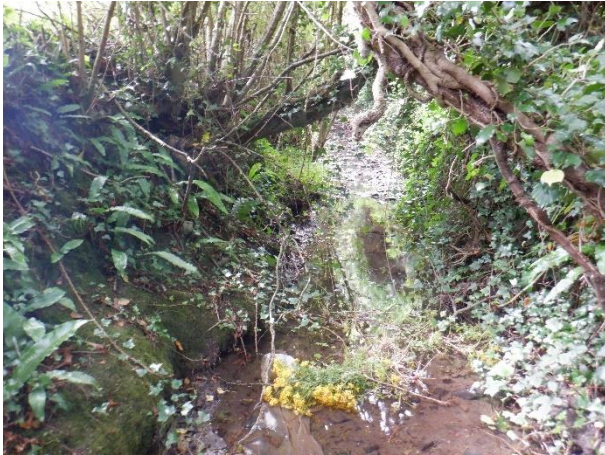
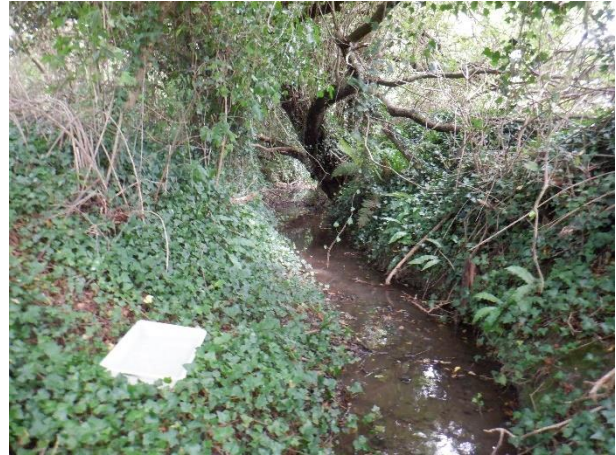
The stream substrate was dominated by gravels with some cobbles present and moderate siltation was observed (10% silt). When the substrate was disturbed a heavy plume of silt was formed indicating siltation within the gravel interstices. Although flow was very low at the time of survey it is evident from erosion of the banks that flows can be quite high and fast during periods of heavy rainfall as the water is funnelled through the narrow channel.

Plate 4-1: Crockshane stream looking upstream at Site 1.

Plate 4-2: Crockshane stream looking downstream at Site 1.

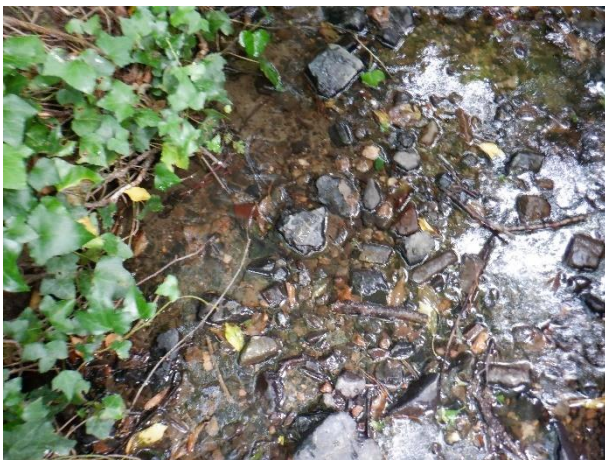
Plate 4-3: Example of river substrate within the Crockshane stream

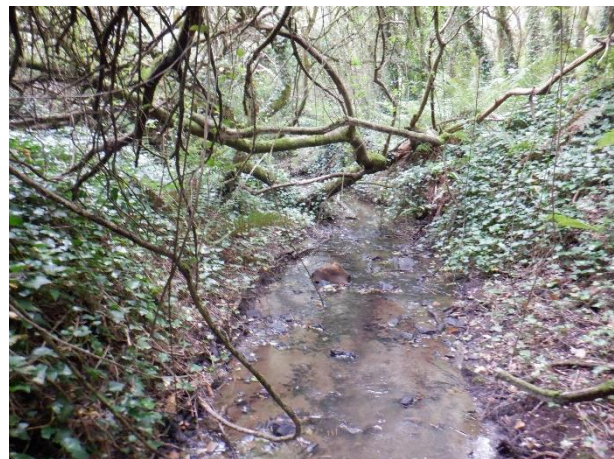
The stream substrate was dominated by gravels with some cobbles present and heavy siltation was observed (20% silt). In very slow-moving sections 100% of the substrate surface was covered in silt. When the substrate was disturbed a heavy plume of silt was formed indicating siltation within the gravel interstices also. Although flow was low at the time of survey it is evident from the erosion of the banks that flows can be quite high and fast during periods of heavy rainfall.

Plate 4-5: Coolmine stream facing upstream at Site 2.

Plate 4-6: Coolmine stream facing downstream at Site 2.

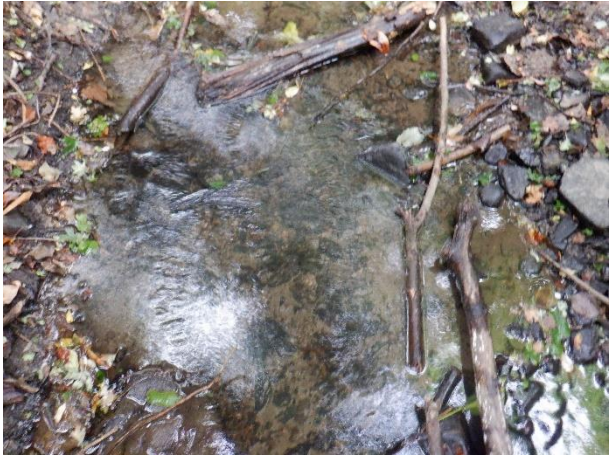
Plate 4-7: Example of typical substrate within the Coolmine

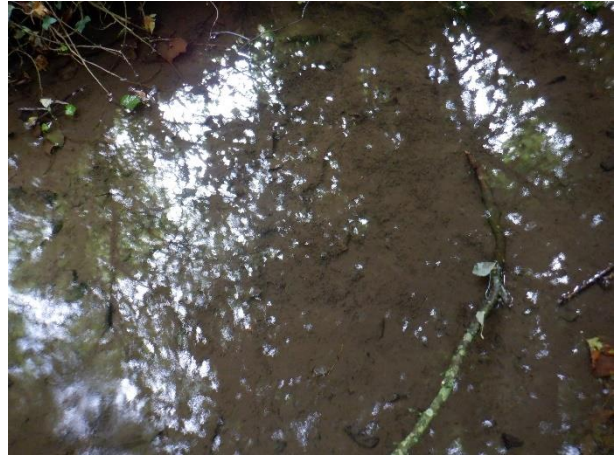
Plate 4-8: Example of heavy siltation of the substrate in slower moving sections of the Coolmine.

In addition, siltation of the substrate in both streams was another pressure identified. While some silt is a natural feature, excessive siltation can impact water quality. It can smother river substrates altering the habitat for aquatic plants and macroinvertebrates leading to changes in the community composition. Excessive fine sediments can degrade spawning habitat, lead to increased egg mortality and even cause damage to fish gills (Kemp et al., 2011; Cocchiglia et al., 2012). Sources of silt in the woodland could be from upstream point sources such as cattle access points but it is also clear that the banks are heavily eroded during periods of high flows contributing to the silt load in the streams.

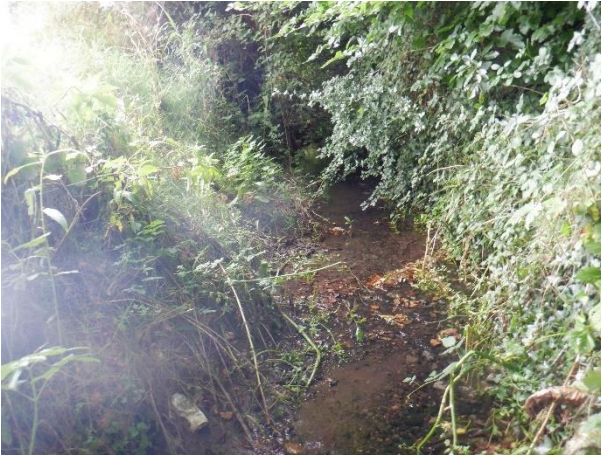
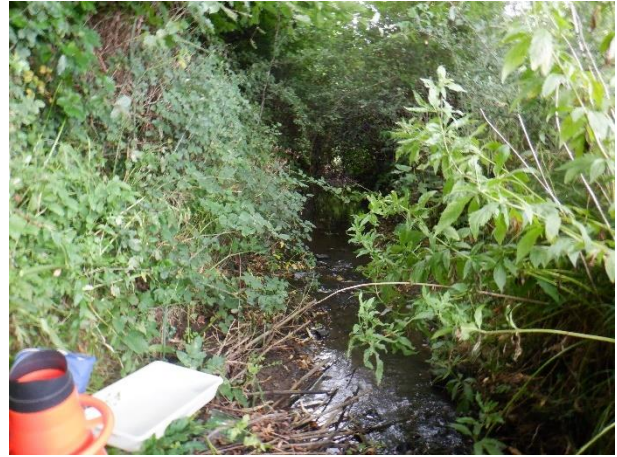
Further downstream at Site 3 conditions were similar with a narrow channel (1m wetted width) and clear shallow water (0.1m depth). Flow was slow and the river flow habitat continued as a uniform glide. The stream follows a modified channel which has been straightened, widened and deepened historically with steep high banks (2m). This makes the majority of the Coolmine stream flowing through the woodland cut off from a floodplain. Bankside vegetation consisted of a beech (*Fagus sylvatica*) and hawthorn (*Crataegus monogyna*) dominated treeline along the left bank with lime trees (*Tilia* sp.), grasses, meadowsweet (*Filipendula ulmaria*) and bramble (*Rubus fruticosus* agg.) along the right bank. The amenity grass of Rathcoole Park forms the riparian buffer along the left bank while along the right bank the grassland habitat identified as Annex I Lowland hay meadow (Hodd, 2021) is present.

Plate 4-9: Coolmine stream looking upstream at Site 3.

Plate 4-10: Coolmine stream looking downstream at Site 3.

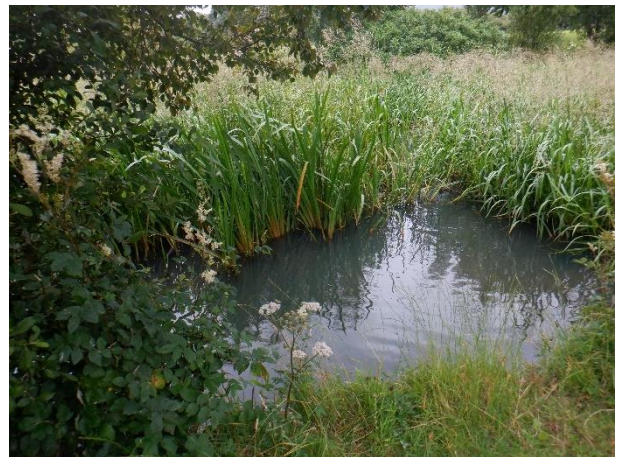
Further downstream where the stream opens out into a series of ponds the water turned from clear to grey coloured. This would indicate that there is potential point source(s) discharge into the ponds either from household or industry misconnections which would need to be further investigated. A misconnection is when wastewater from showers, toilets, sinks, washing machines, dryers are connected to the surface water network instead of the sewage network.

Plate 4-14: Grey coloured water within the ponds in Rathcoole Park indicating point source(s) pollution

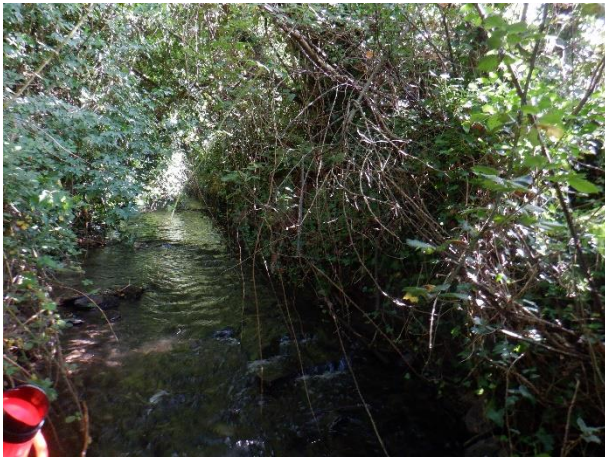
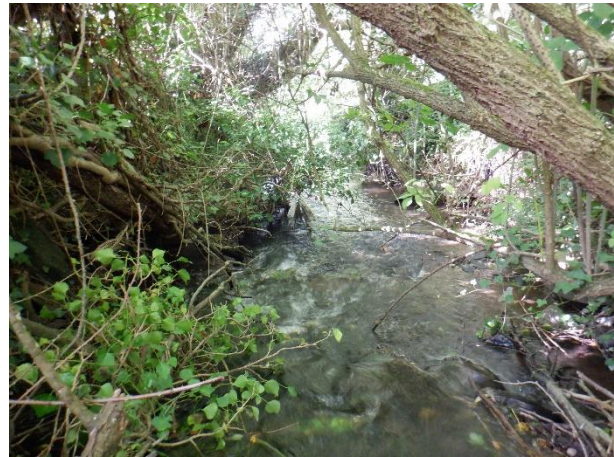
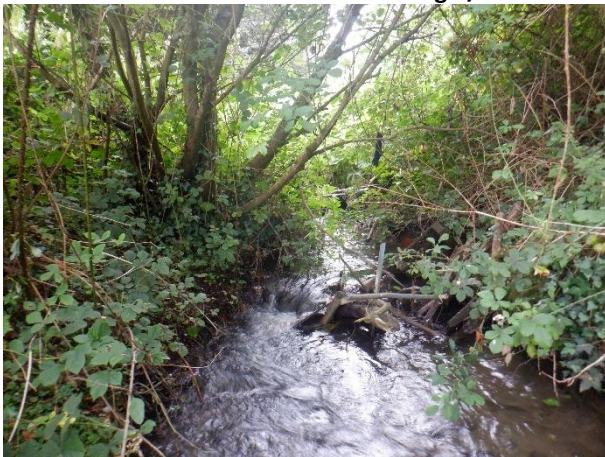
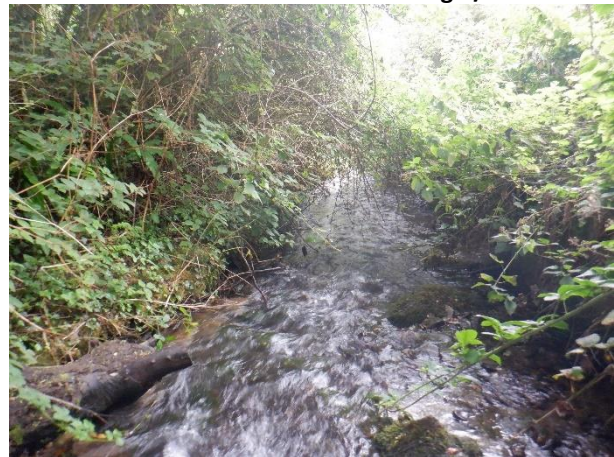
The Camac is larger than the Crockshane and Coolmine streams with a wetted width of 3m at Site 4 and narrows slightly as one moves to the upstream sites. Water levels were between 0.15m to 0.25m with the shallowest water upstream at Site 6. Flow was moderate to fast. Habitat is dominated by riffle and glide with only the occasional deeper pools at Sites 4 and 5 but no pools were present at Site 6. The banks are steep (2-3m height) and the river is constrained within the bank with limited access to a natural floodplain at all sites.

Plate 4-15: Camac River at Site 4 looking u/s

Plate 4-16: Camac River at Site 4 looking d/s

Plate 4-17: Camac River at Site 5 looking u/s

Plate 4-18: Camac River at Site 5 looking d/s

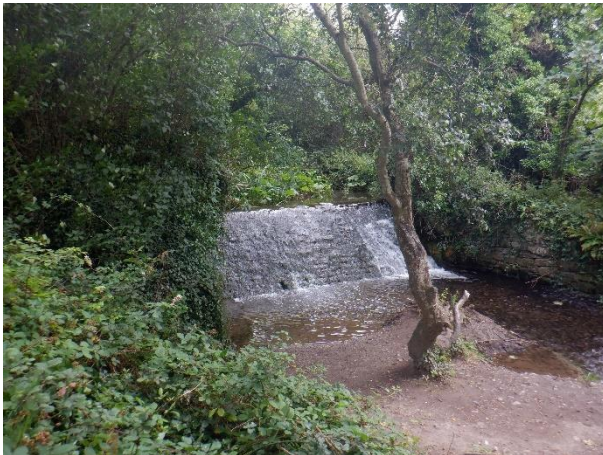
A weir is present on the Camac just beside the Swiftbrook Millpond (east) and IFI have classed this weir as a barrier to fish migration which would include crayfish.

Plate 4-19: Wier on the Camac which is classed as a barrier by IFI for fish and crayfish.

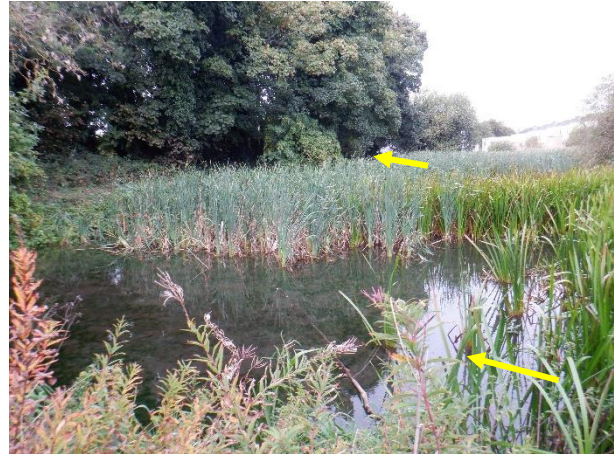
Most of the pond is heavily vegetated with reedmace (*Typha latifolia*) with an open water area mainly concentrated in the southern section of the pond and small open areas along margins. Other aquatic vegetation included reed canary grass (*Phalaris arundinacea*) and floating lesser duckweed (*Lemna minor*). Five traps were deployed along the eastern, southern and western margins of the pond. No crayfish were caught in any of the five traps.

Owing to the very dense emergent vegetation in this pond the habitat is sub-optimal for crayfish in the majority of the pond.

Plate 4-22: Millpond along the southern section with dense Typha stand visible. Yellow arrow shows approximate location of the inflow and outflow.

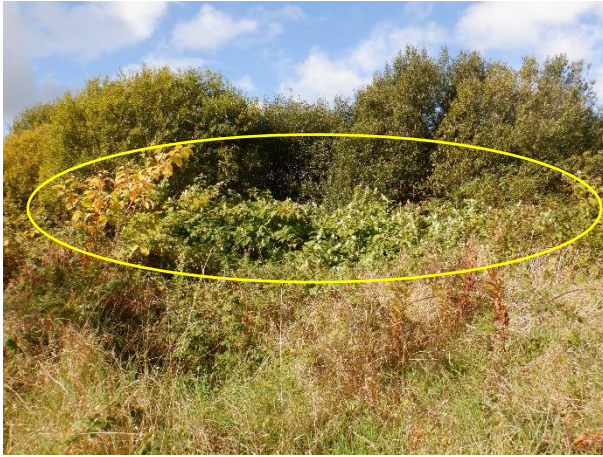
One invasive species listed on the Third Schedule was identified within Rathcoole Woodlands during the survey. This was **Japanese knotweed (*Reynoutria japonica*)** which is classed as having a risk of high impact in a risk assessment of invasives of Ireland (Kelly et al., 2013). The knotweed was identified to the east of the site in an area of immature woodland and scrub (53.27935, -6.45623). This is the same location where it had been noted in previous surveys (Wilson & Denyer 2021; Hodd, 2021). The knotweed is adjacent to calcareous spring habitat identified by Wilson & Denyer (2021). In the same report it was noted that the habitat does not conform to Annex I Petrifying Springs but is considered to be Local (Higher) ecological importance.

Plate 4-25: Stand of Japanese knotweed identified close to the Crockshane stream.

Knotweed spreads easily when disturbed via fragmentation of rhizomes (underground modified stems) and should not be cut or trimmed as a control method. It should be treated using proper application of herbicides approved for use near water by a qualified user. If not in place already, a management plan should be developed by those responsible for the lands to map the extent of the infestation and outline the method of control.

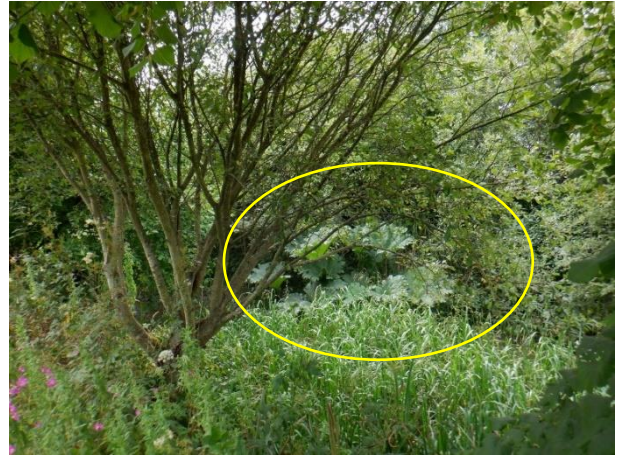
A second third schedule invasive species was noted within Rathcoole Park outside of the woodlands. This was **giant rhubarb (*Gunnera tinctoria*)** located on the right bank of the Coolmine stream just as it enters the ponds (53.28159, -6.45893). This plant is also classed as having a risk of high impact. The plant produces a high number of seeds which are spread via water and also birds. It can also spread cl via rhizomes. Given that the plant is located on the bank of the Coolmine before the ponds which contain wildfowl there is a risk of further spread. Its huge leaves impact local biodiversity through light exclusion and like knotweed when it dies back in winter the soil along the bank is exposed to erosion.

Plate 4-26: Gunnera identified along the Coolmine stream highlighted in the yellow circle.
